Indy Inspection Service, Inc.
PO Box 199300
Indianapolis, IN 46219

HOME INSPECTION REPORT

Sample St.

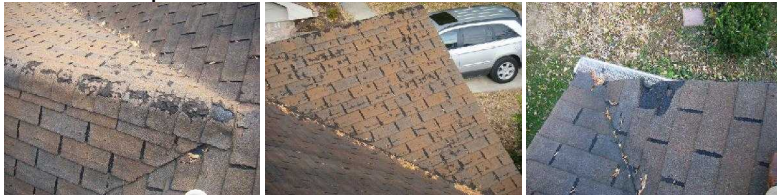
1. Method of Inspection: On roof
2. Material: 3-tab shingle Roof at end of useful life. Replace roofing. Roofing is damaged near N/W corner. Repair.

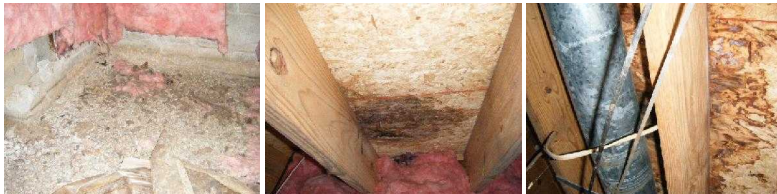
- 12. Vapor Barrier: Under entire home Respread +/- or add vapor barrier to cover entire crawl space floor, Remove debris from under vapor barrier
- 13. Sump Pump: Pump works A second sump pit is located near the access, but no pump is installed. There is piping for a pump to discharge to the sewer, which is not allowed.
- 14. Electrical: 2 of 3 light fixtures not working. Replace bulb(s) or repair as required.
- 15. Observations Animal feces in crawl space. Remove. Moisture stain on subfloor near south wall 10' east of S/W corner. Moisture stain under kitchen sink. Monitor these areas.

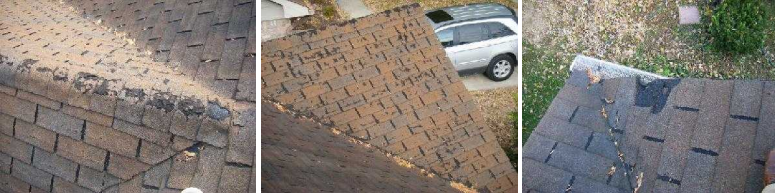
1. Front Roof Surface Material: 3-tab shingle Roof at end of useful life. Replace roofing. Roofing is damaged near N/W corner. Repair.

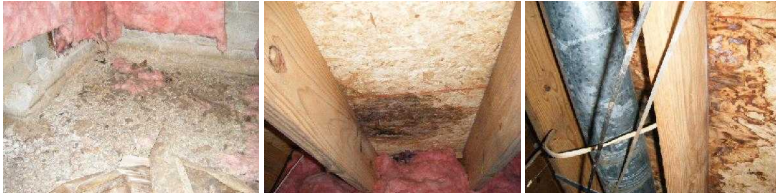
- 20. Via exterior panel Crawl Space Observations Animal feces in crawl space. Remove. Moisture stain on subfloor near south wall 10' east of S/W corner. Moisture stain under kitchen sink. Monitor these areas.
